**FOURTH FIVE-YEAR REVIEW REPORT  
SOLID STATE CIRCUITS, INC. SUPERFUND SITE  
REPUBLIC, GREENE COUNTY, MISSOURI**

**Missouri Department of Natural Resources  
Hazardous Waste Program  
Jefferson City, Missouri**

**U.S. Environmental Protection Agency  
Region VII  
Kansas City, Kansas**

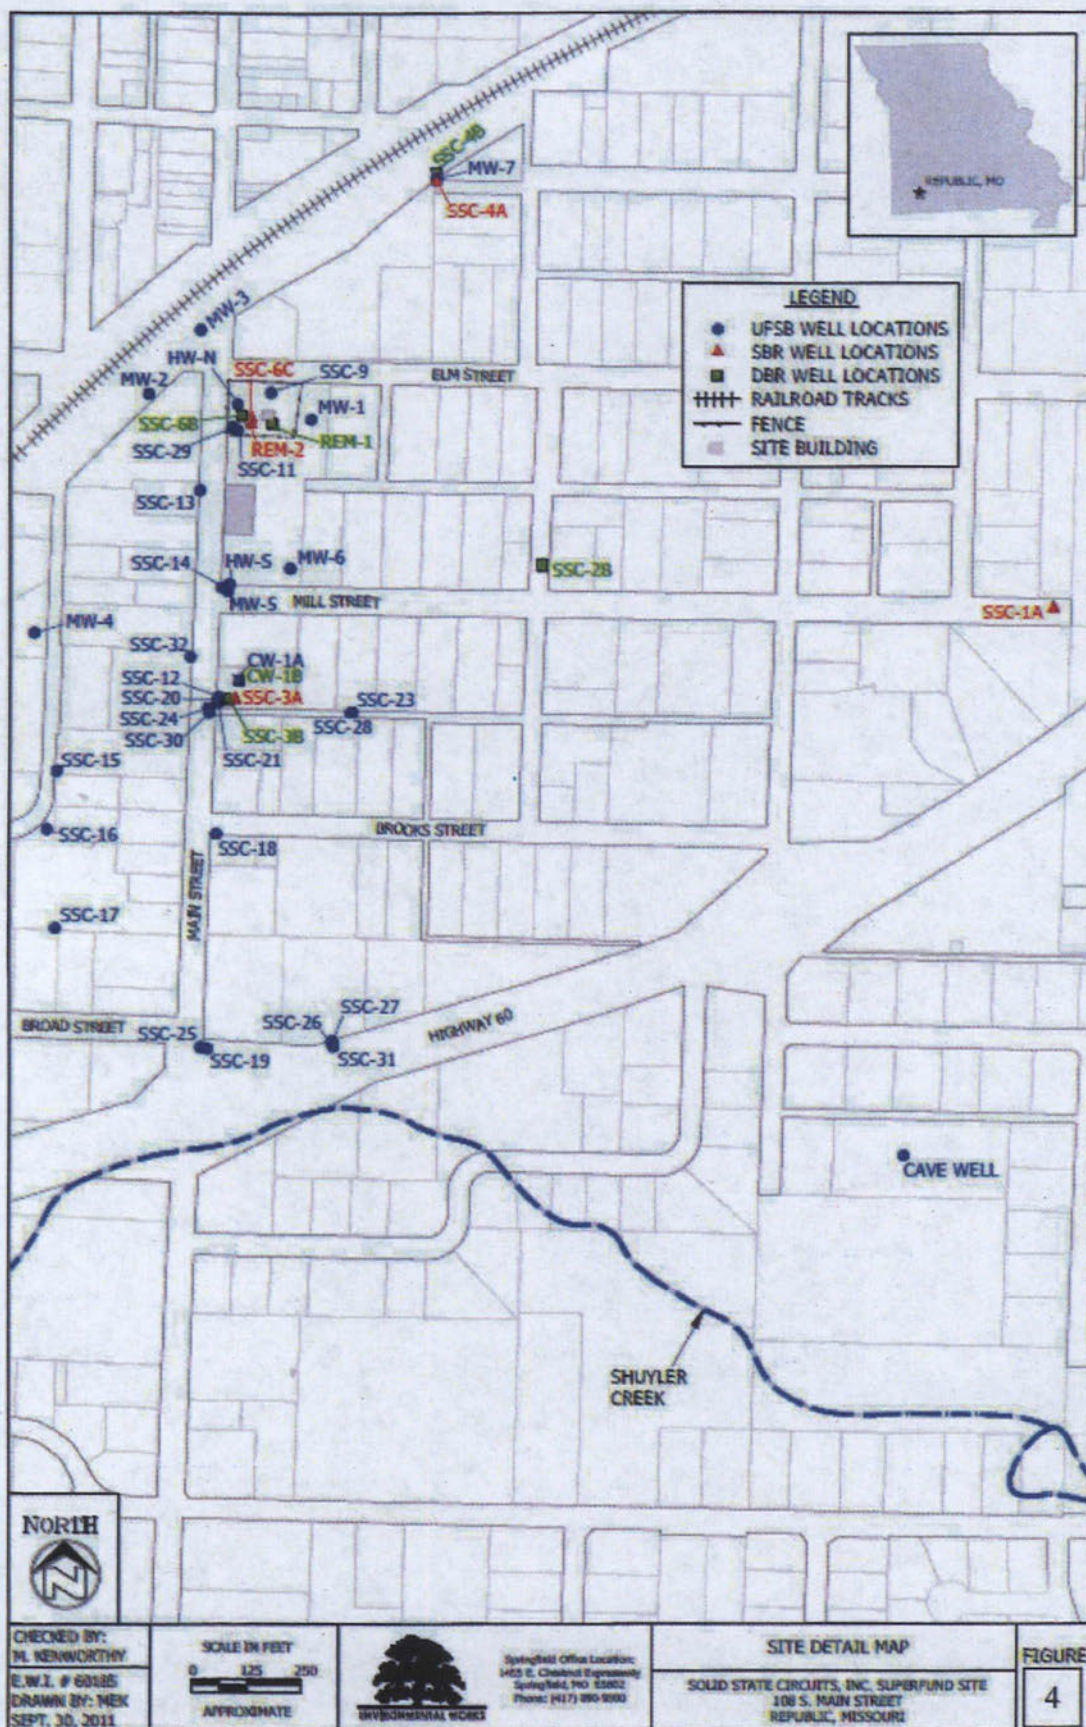
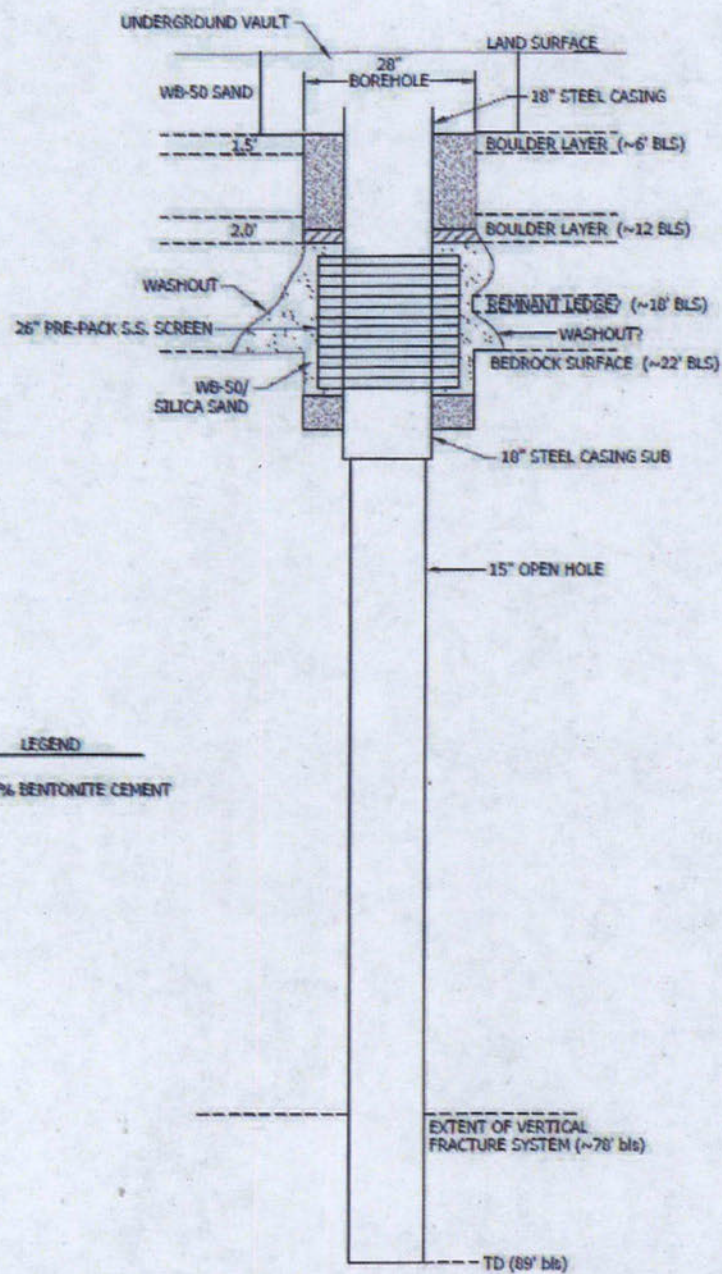
This issue was resolved. The accumulation of silt within SSC-30 was removed by MRAC in November 2008. A new screen was placed within the existing damaged screen, and the pump intake was reset to its original depth (Figures 5 and 6). The figures show the original and modified construction of extraction well SSC-30.

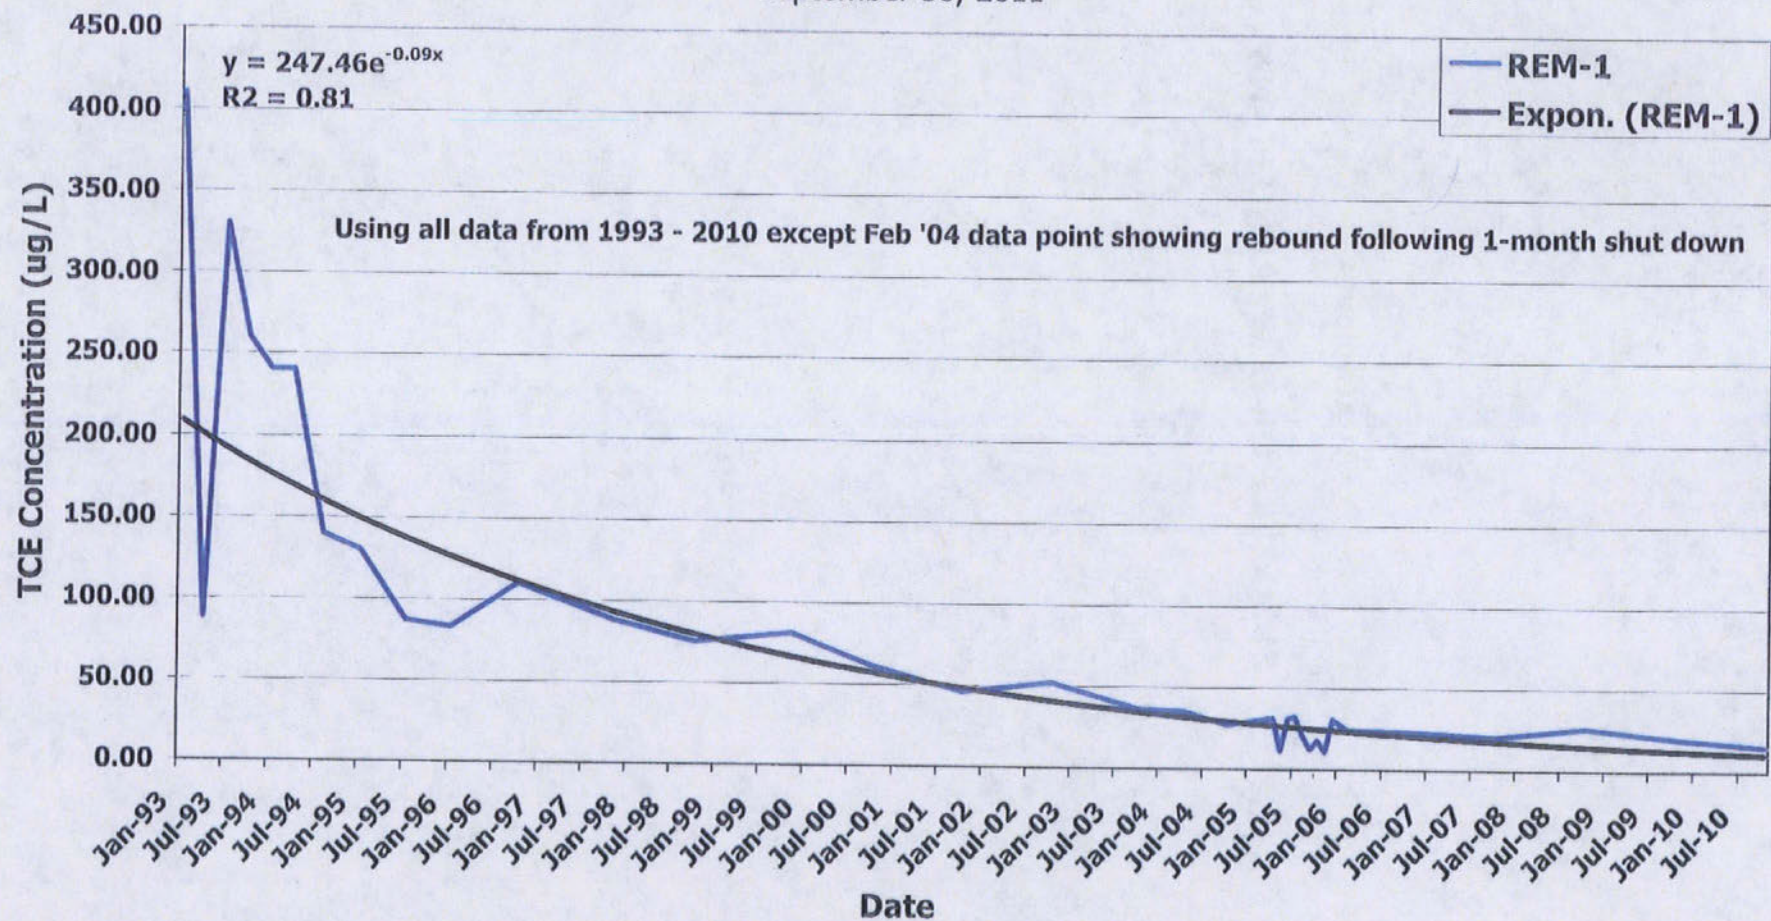
**FIGURE 2-6**  
**TCE Concentration Trend in DBR Well REM-1 (1993-2010)**  
**Solid State Circuits, Inc. Superfund Site**  
**Republic, Missouri**  
 September 30, 2011

- TCE concentrations in extraction well REM-1 ranged from 15.3 µg/L (2010) to 26.0 µg/L (2008) (Figure 2-6). To provide updated cleanup time frames based on current data, regression analyses were applied to REM-1 (Table 5). Based on the trends, regression analyses indicated that an additional 43 years are needed to reach the MCL.
- TCE concentrations in monitoring well SSC-3B ranged from 1.1 µg/L (2010) to 3.2 µg/L (2007).
- TCE was not detected in monitoring wells SSC-2B, SSC-4B, and SSC-6B during the fourth FYR.
- TCE was not detected in the Republic/Brookline municipal wells CW-3, CW-4, CW-5 or CW-6. On June 20, 2007, CW-6 went online in the consolidated Republic-Brookline area. Annual sample collection began on CW-6 in October 2007.

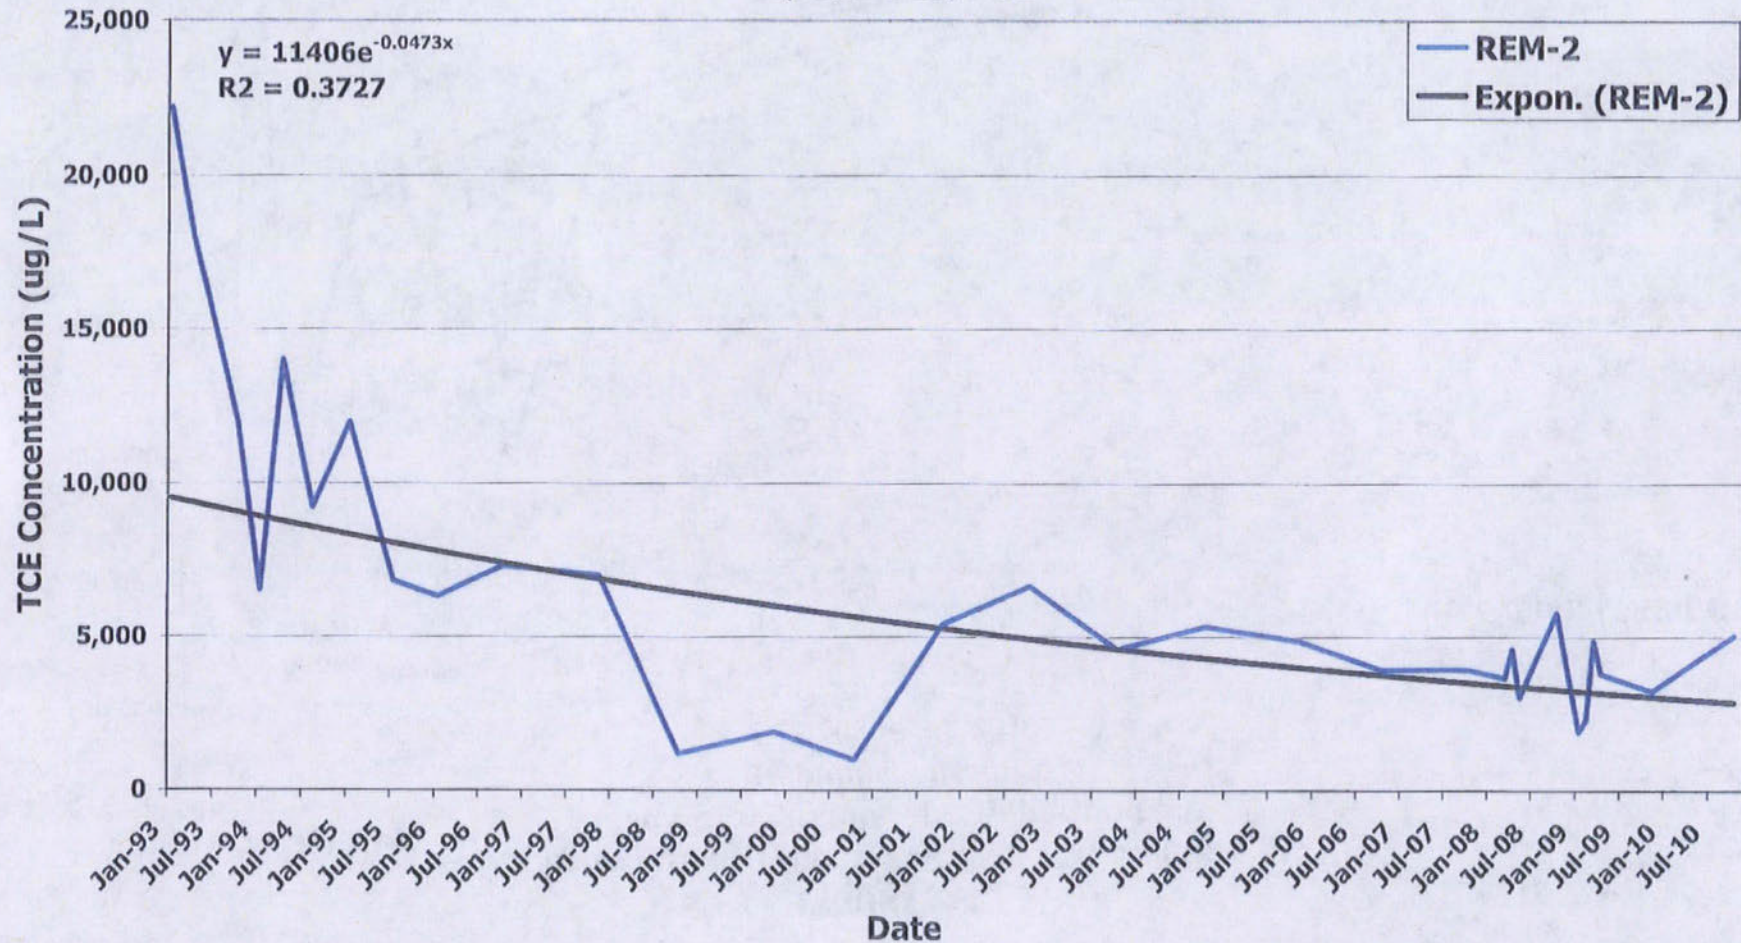
**FIGURE 2-12**  
**TCE Concentration Trend in SBR Well REM-2 (1993-2010)**  
**Solid State Circuits, Inc. Superfund Site**  
**Republic, Missouri**  
 September 30, 2011

- There are no SBR monitoring locations providing data that could be used to define a clean southern boundary of the plume.
- TCE concentrations in extraction well REM-2 ranged from 1,910 µg/L (2009) to 5,800 µg/L (2008) (Figure 2-12).

- TCE concentrations in extraction well SSC-6C ranged from 2,200 µg/L (2009) to 10,400 µg/L (2010) (Figure 2-13).
- Historically, TCE concentrations in REM-2 were generally lower than SSC-6C (Figures 2-12 and 2-13). To provide updated cleanup time frames based on current data, regression analyses were applied to REM-2 and SSC-6C (Table 5). Based on the trends, regression analyses indicated that an additional 144 years (REM-2) and 78 years (SSC-6C) are needed to reach the MCL. The calculated time frame does not account for contaminant rebound as noted during the SSI, which could extend the calculated time frame.

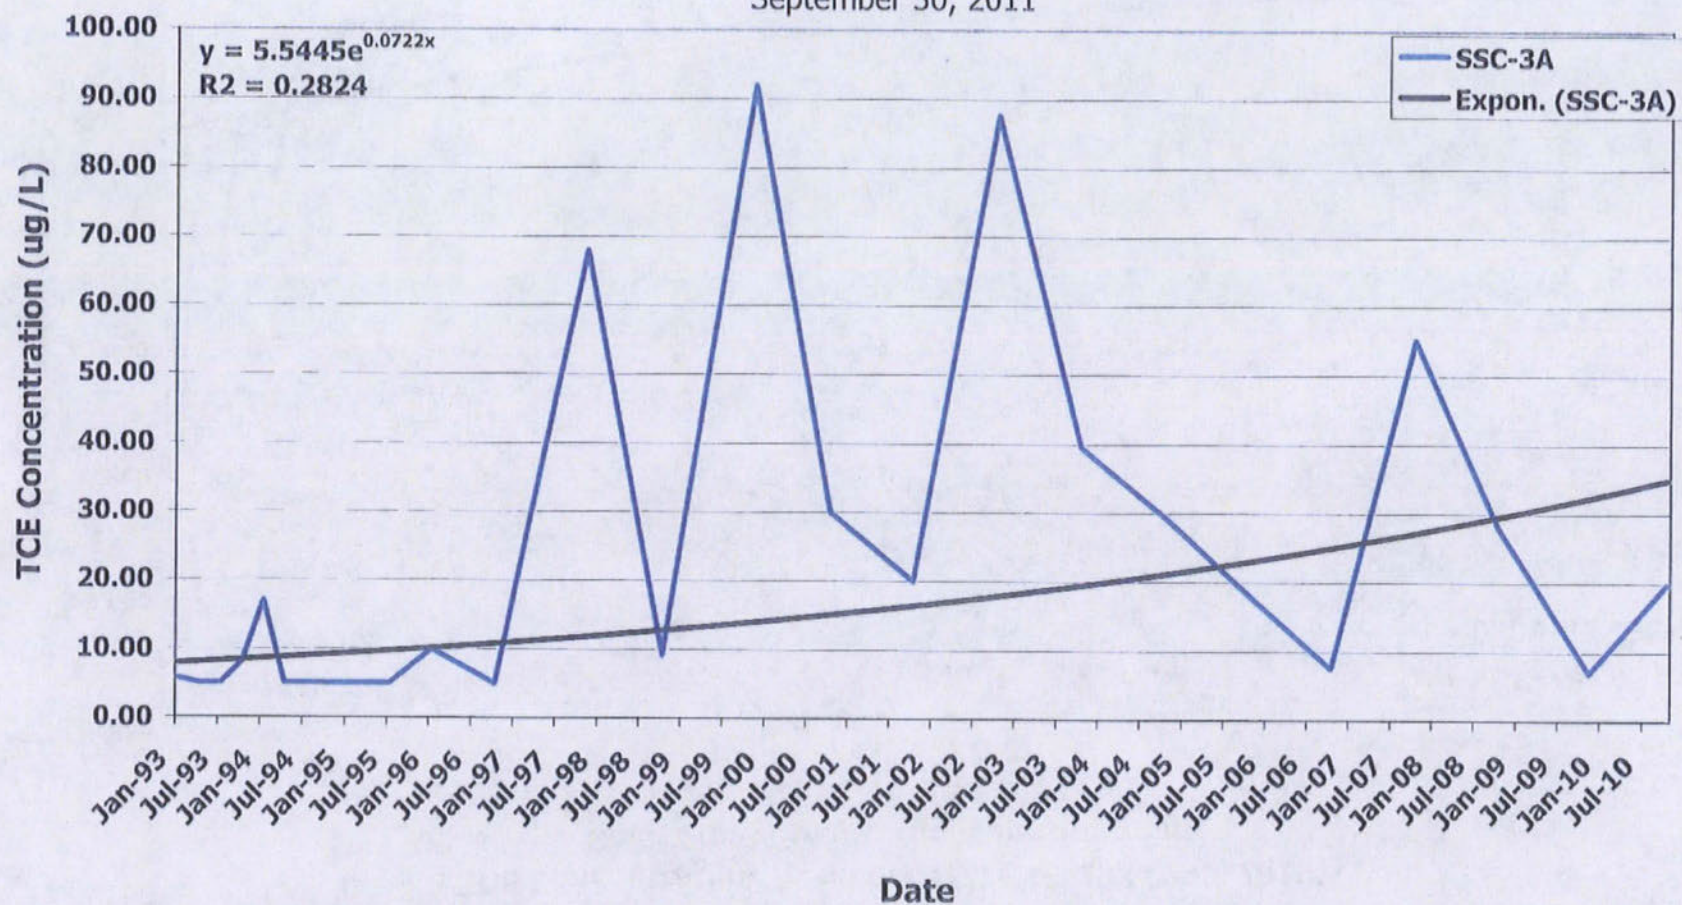
**FIGURE 2-14**  
**TCE Concentration Trend in UFSB Well SSC-3A (1993-2010)**  
**Solid State Circuits, Inc. Superfund Site**  
**Republic, Missouri**  
 September 30, 2011

- TCE concentrations in monitoring well SSC-3A ranged from 7.56 µg/L (2006) to 55.2 µg/L (2007) (Figure 2-14). The contaminant impacts to SSC-3A may be a result of its proximity to the Main Street Fracture System (MSFS) and well construction. Based on the possibility that a higher conductive unit may exist at depths of approximately 175 to 210 feet bls, EWI proposed an additional downhole characterization for SSC-3A.

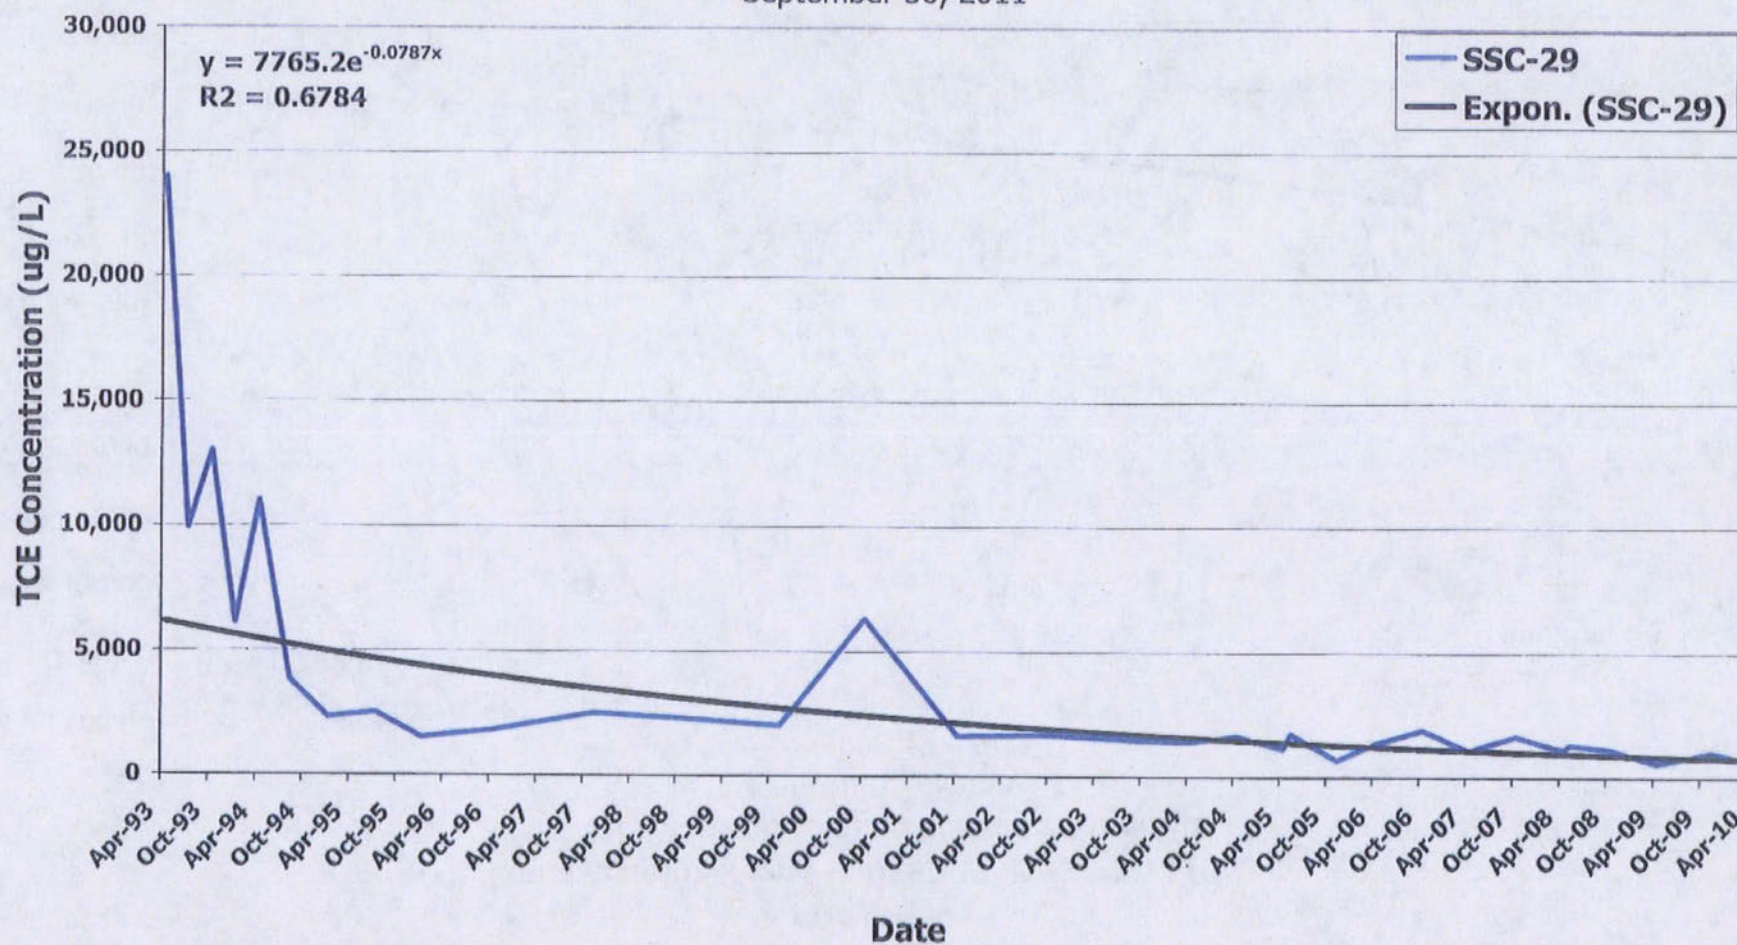
**FIGURE 2-20**  
**TCE Concentration Trend in UFSB SSC-29 (1993-2010)**  
**Solid State Circuit, Inc. Superfund Site**  
**Republic, Missouri**  
 September 30, 2011

- TCE concentrations ranged in extraction well SSC-29 from 574 µg/L (2009) to 2,660 µg/L (2008) (Figure 2-20).
- TCE concentrations ranged in monitoring well SSC-11 from 694 µg/L (2007) to 1,470 µg/L (2010) (Figure 2-21).

- TCE concentrations in extraction well SSC-29 and monitoring well SSC-11 remained relatively stable (Figures 2-20 and 2-21). To provide updated cleanup time frames based on current data, regression analyses were applied to SSC-29 and SSC-11 (Table 5). Based on the trends, regression analyses indicated that an additional 43 years (SSC-29) and 15 years (SSC-11) are needed to reach the MCL. The calculated time frame does not account for contaminant rebound as noted during the SSI, which could extend the calculated time frame.

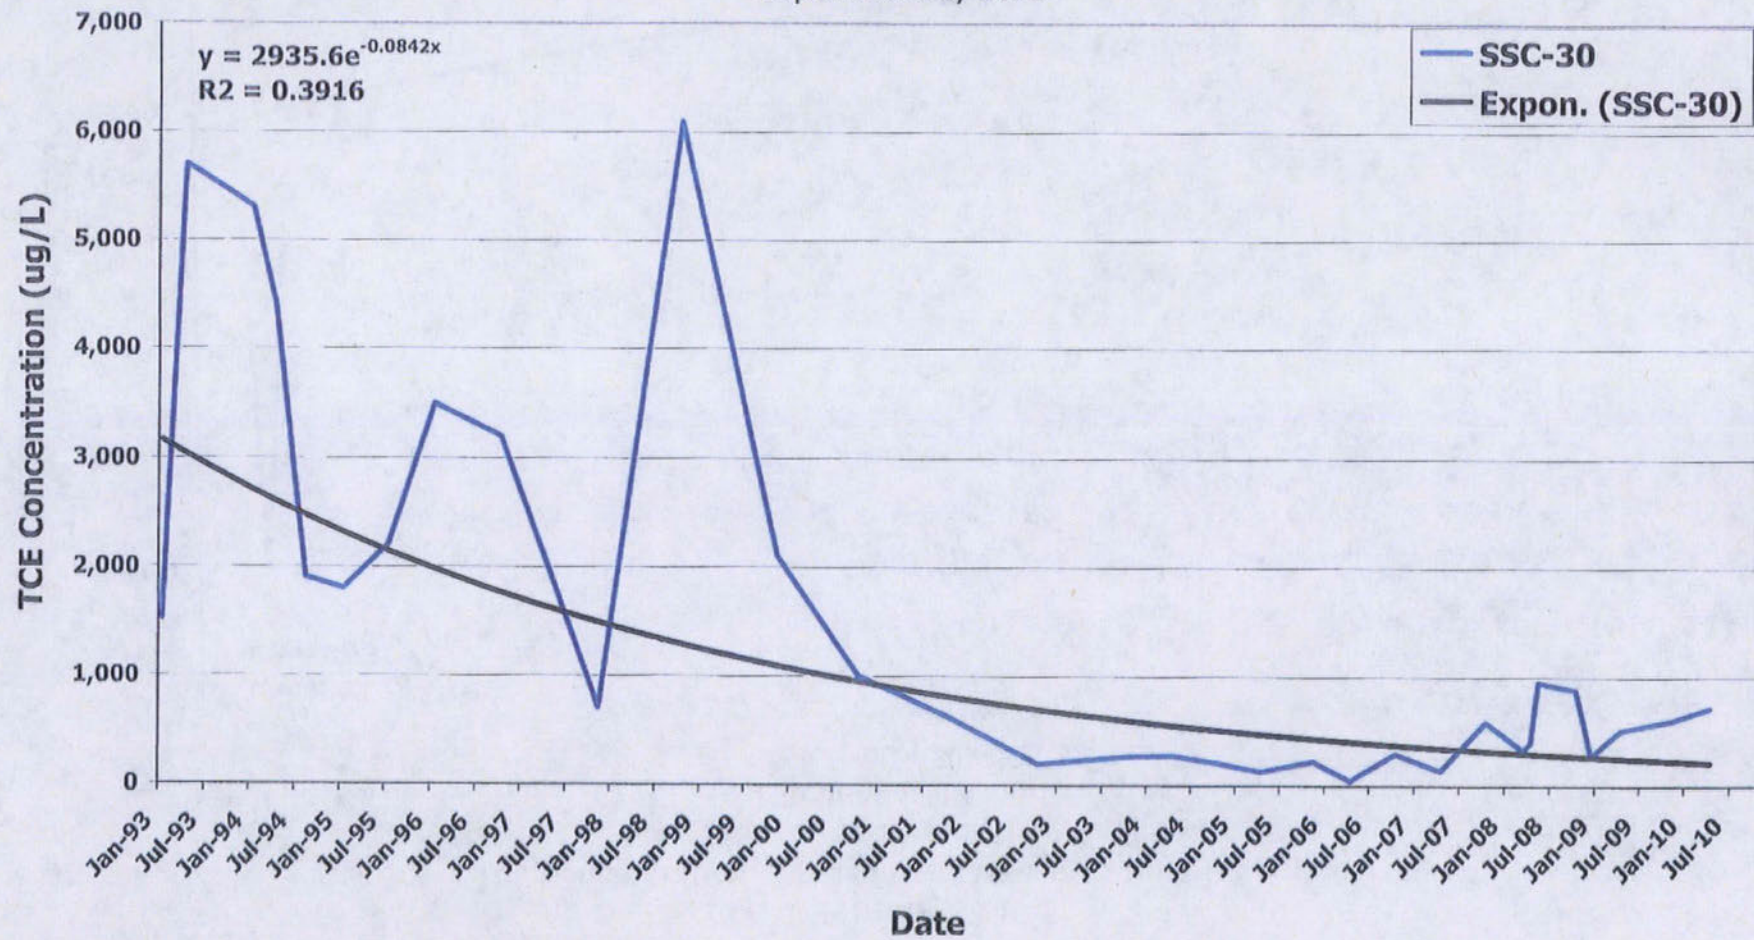
**FIGURE 2-22**  
**TCE Concentration Trend in UFSB Well SSC-30 (1993-2010)**  
**Solid State Circuits, Inc. Superfund Site**  
**Republic, Missouri**  
 September 30, 2011

- TCE concentrations ranged in extraction well SSC-30 from 41.6 µg/L (2006) to 950 µg/L (2008). The TCE concentration variations were impacted mostly by external events (Figure 2-22). After the initiation of the one-year horizontal well pilot test, TCE concentrations ranged from 41.6 µg/L (2006) to 291 µg/L (2007). Following the repair of a city of Republic water main leak in March 2008, TCE concentrations ranged from 274 µg/L (2009) to 950 µg/L (2008) due to the removal of "clean water" dilution near SSC-30.

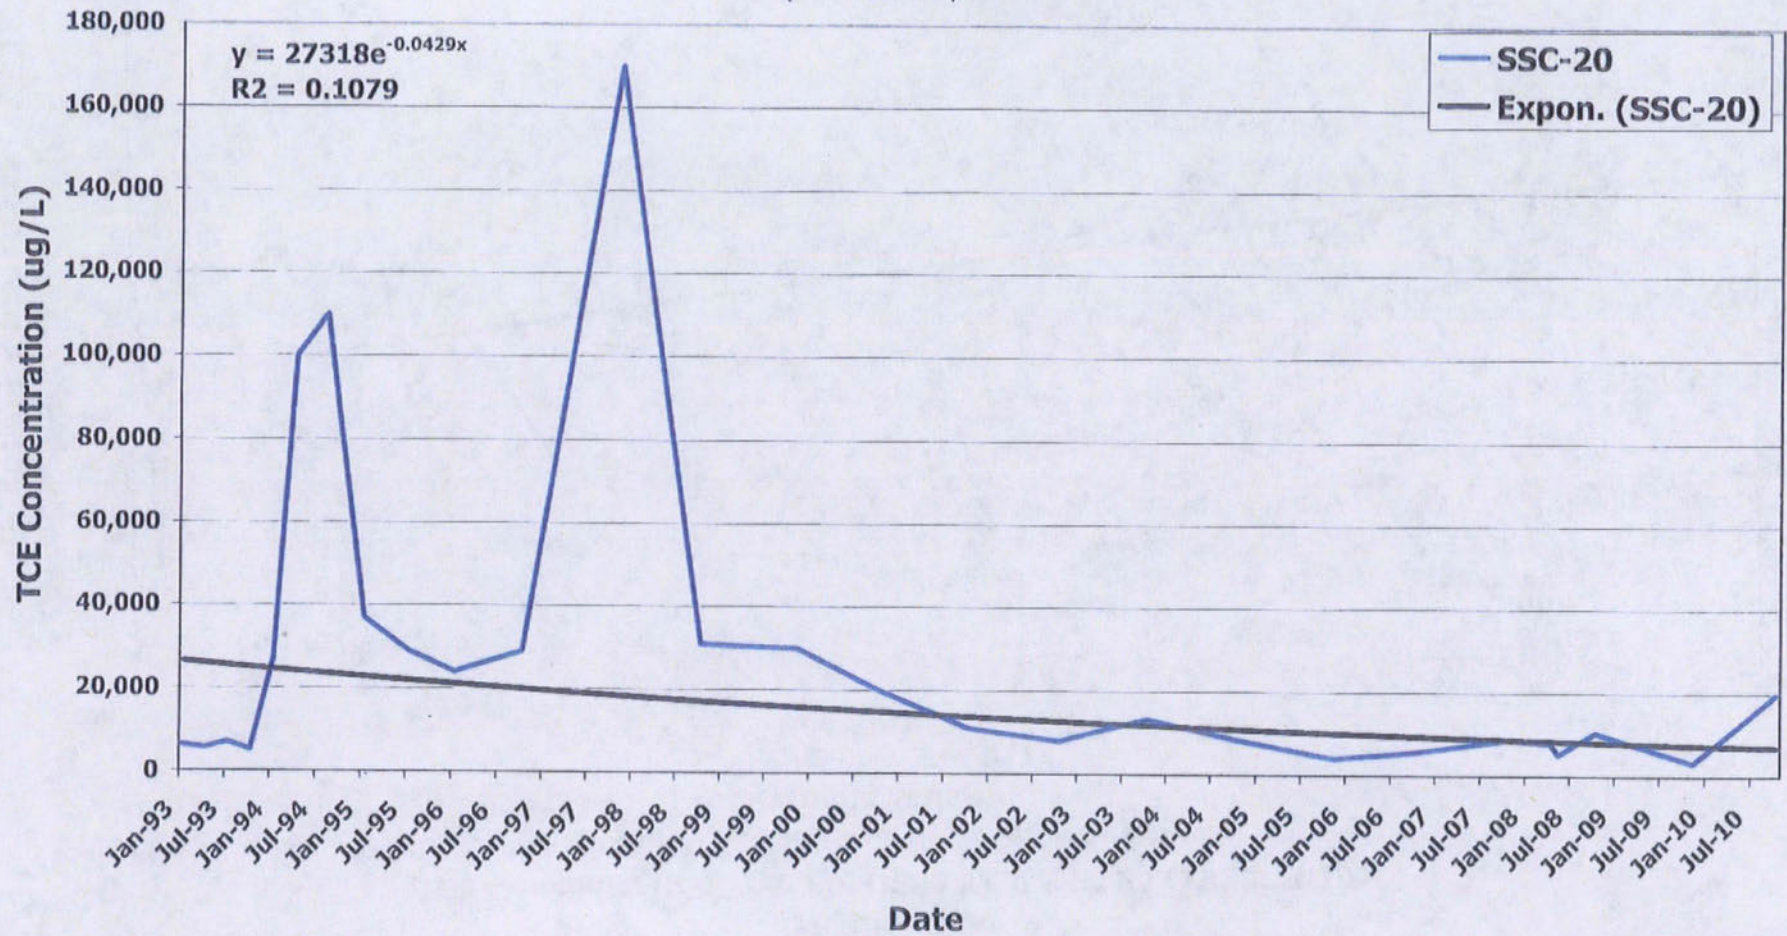
**FIGURE 2-23**  
**TCE Concentration Trend in UFSB Well SSC-20 (1993-2010)**  
**Solid State Circuits, Inc. Superfund Site**  
**Republic, Missouri**  
 September 30, 2011

- Monitoring wells SSC-20, SSC-24, and SSC-32 are located near SSC-30. TCE concentrations in SSC-20 ranged from 467 µg/L (2010) to 19,800 µg/L (2010) and exhibited the highest TCE concentrations within the UFSB (Figure 2-23). The higher TCE concentrations at SSC-20 may be due to a smaller screened interval and/or the screened interval location. TCE concentrations in SSC-24 ranged from 50.2 µg/L (2010) to 1,460 µg/L (2007) and the TCE concentrations in SSC-32 ranged from 140 µg/L (2010) to 268 µg/L (2007) (Figures 2-24 and 2-25).

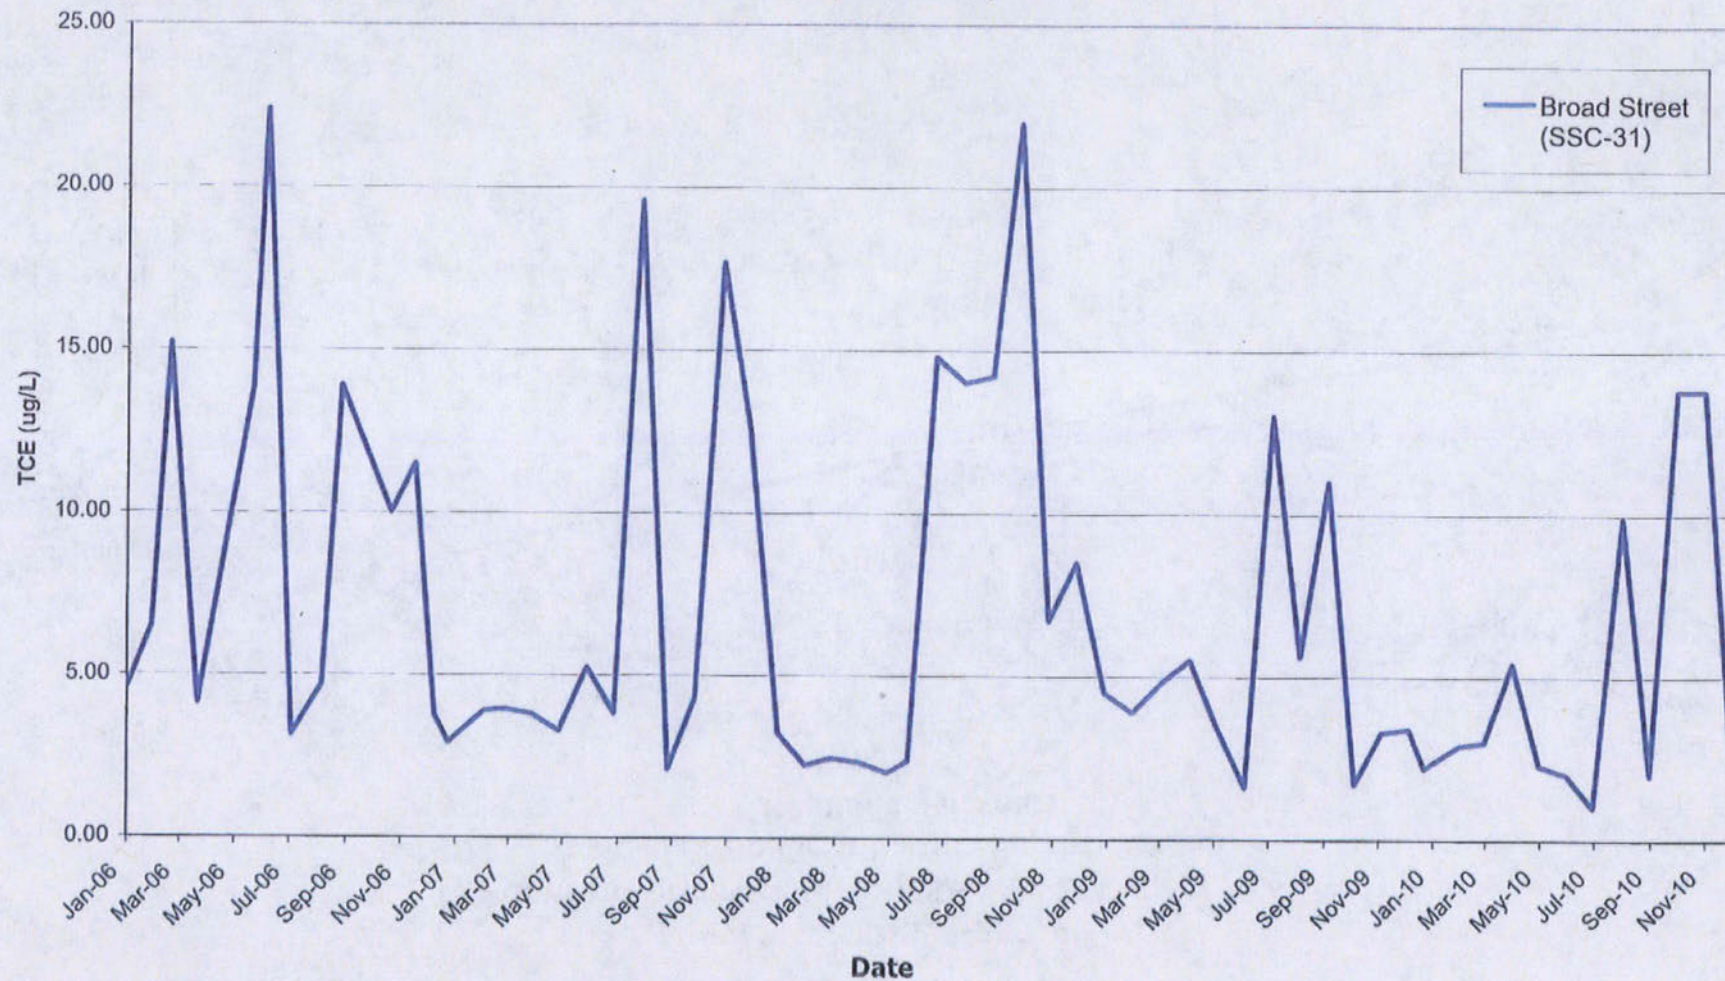
**FIGURE 2-26**  
**TCE Concentration Trend in UFSB Well SSC-31 (2006-**  
**2010)**  
**Solid State Circuits, Inc. Superfund Site**  
**Republic, Missouri**  
**September 30, 2011**

- Groundwater pumped from extraction well SSC-31 is discharged to the Broad Street Sewer. TCE concentrations in the Broad Street Sewer ranged from 2.2 µg/L (2010) to 22.0 µg/L (2008) (Figure 2-27). The data continued to demonstrate the seasonal variability previously documented for this well (Figure 2-26). Based on these trends, regression analyses indicate that an additional 39 years are needed to reach the MCL at SSC-31 (Table 5).

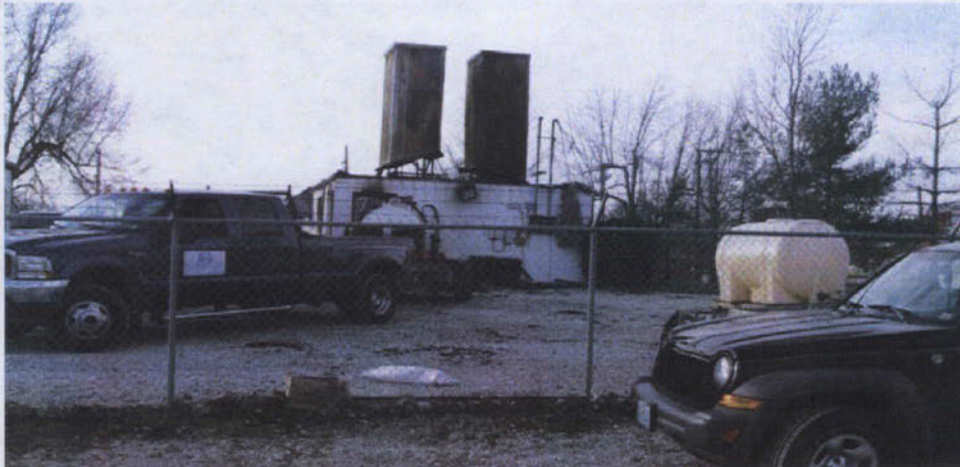
**Photograph 1**

Solid State Circuits Site, Republic, MO  
Date: 12/08/2011, Candice McGhee, DEQ, HWP, SF  
Photo of east side of air stripper (treatment) building.

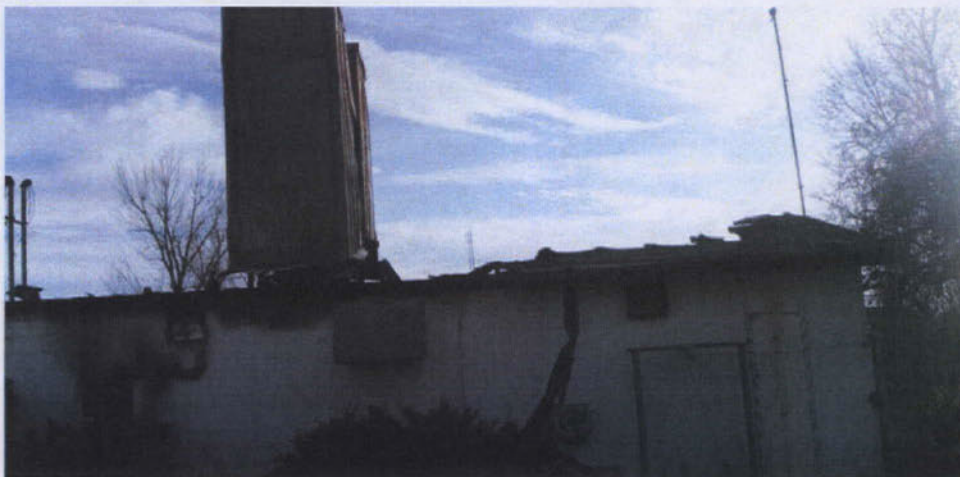
**Photograph 2**

Solid State Circuits Site, Republic, MO  
Date: 12/08/2011, Candice McGhee, DEQ, HWP, SF  
Photo of north side of air stripper (treatment) building. Photo taken  
Facing West towards Main Street.

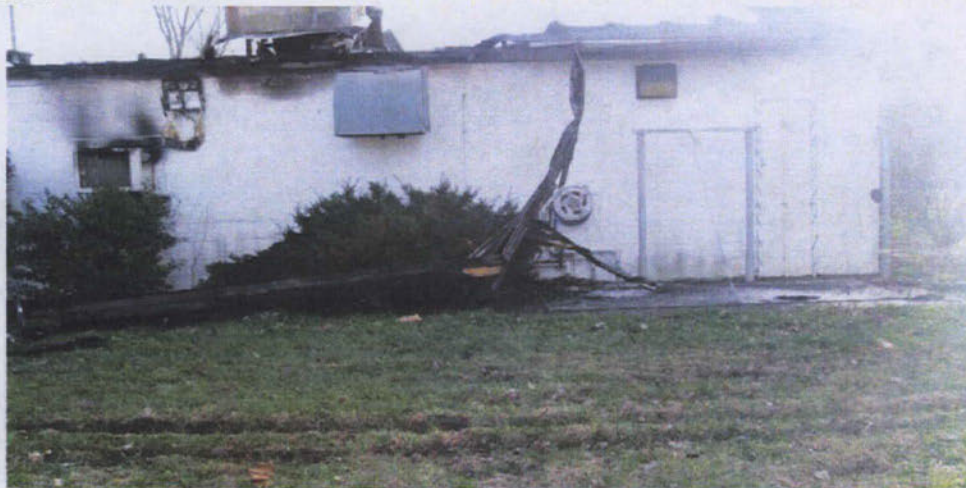
**Photograph 3**

Solid State Circuits Site, Republic, MO  
Date: 12/08/2011, Candice McGhee, DEQ, HWP, SF  
Photo of north side of air stripper (treatment) building

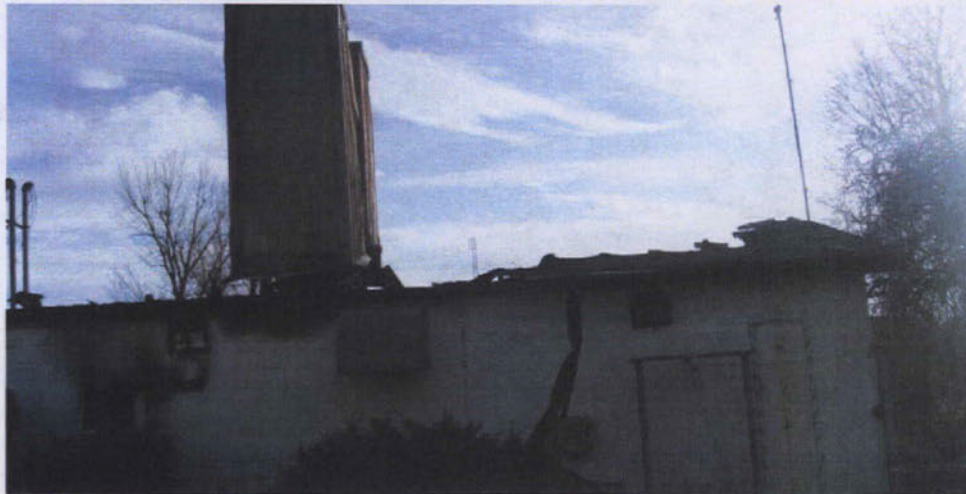
**Photograph 4**

Solid State Circuits Site, Republic, MO  
Date: 12/08/2011, Candice McGhee, DEQ, HWP, SF  
Photo of north side of air stripper (treatment) building

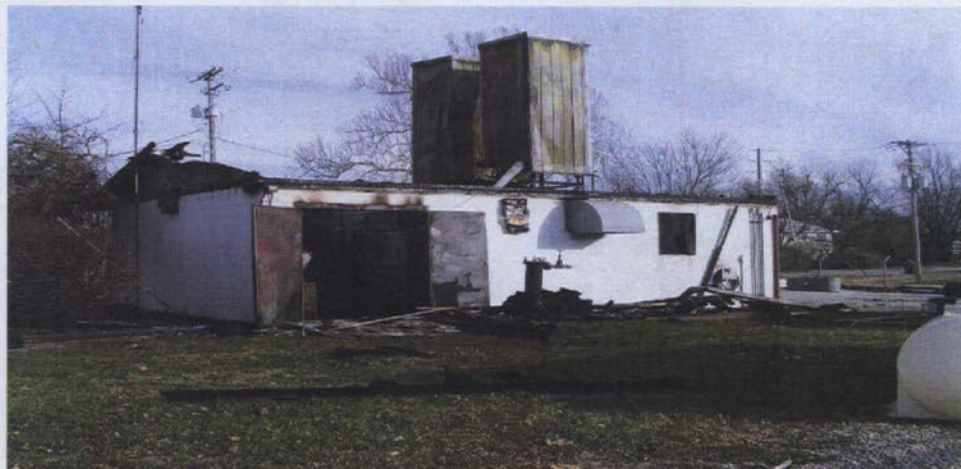
**Photograph 5**

Solid State Circuits Site, Republic, MO  
Date: 12/08/2011, Wendell Hall DEQ, SWRO  
Photo south side of air stripper (treatment) building.

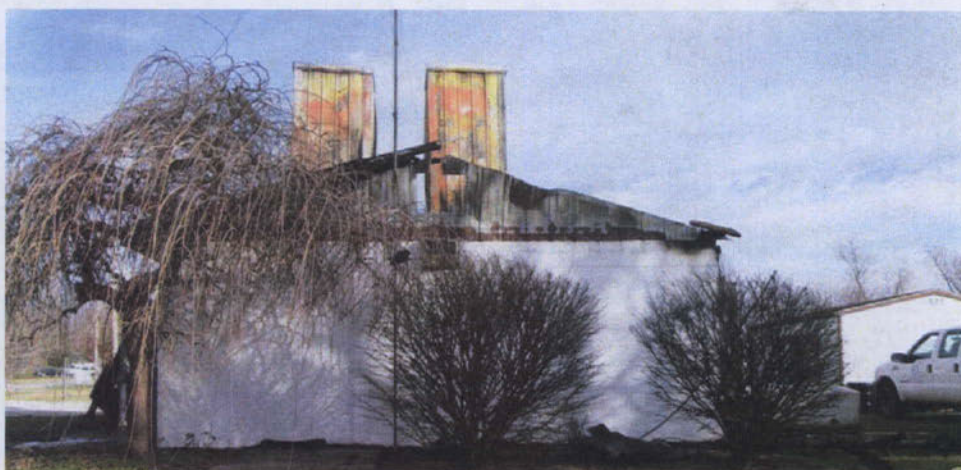
**Photograph 6**

Solid State Circuits Site, Republic, MO  
Date: 12/08/2011, Wendell Hall DEQ, SWRO  
Photo west of air stripper (treatment) building.

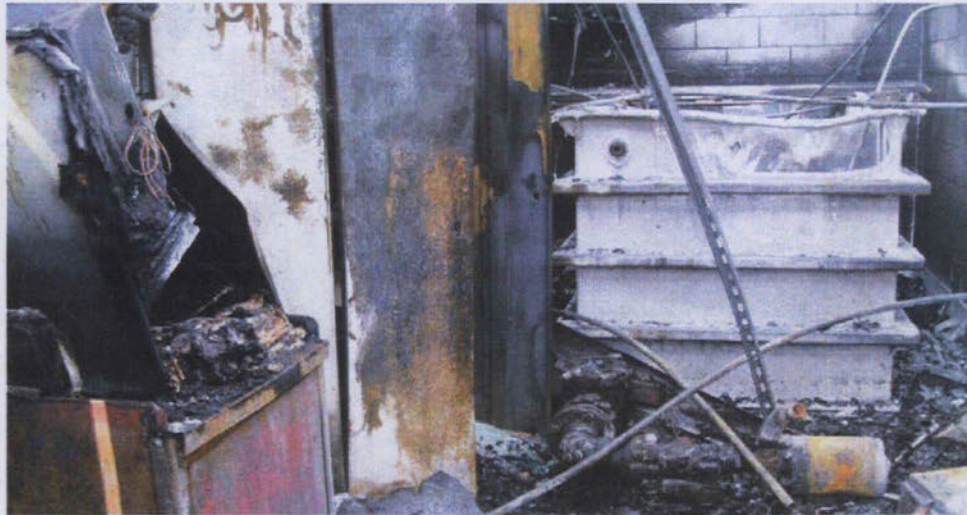
**Photograph 7**

Solid State Circuits Site, Republic, MO  
Date: 12/08/2011, Candice McGhee DEQ, HWP, SF  
Photo of Equalization Tank.

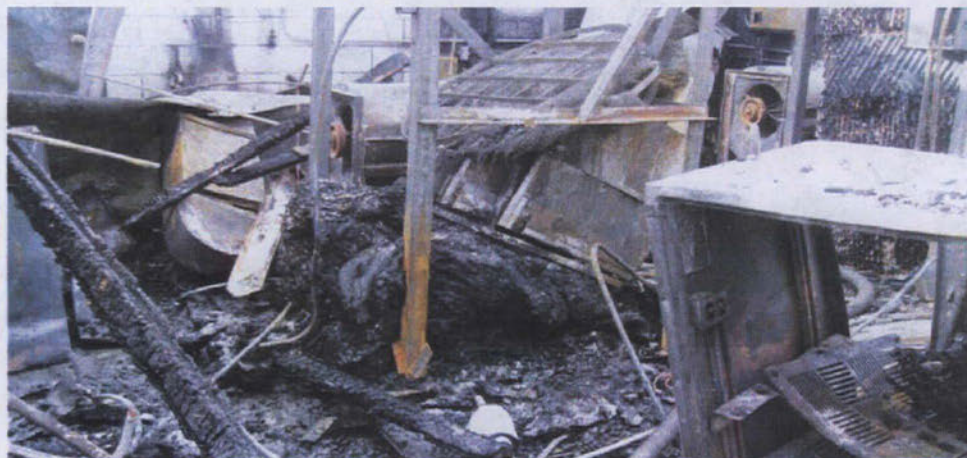
**Photograph 8**

Solid State Circuits Site, Republic, MO  
Date: 12/08/2011, Candice McGhee DEQ, HWP, SF  
Photo of first air stripper & transfer motor (behind legs) and computer shell (foreground).

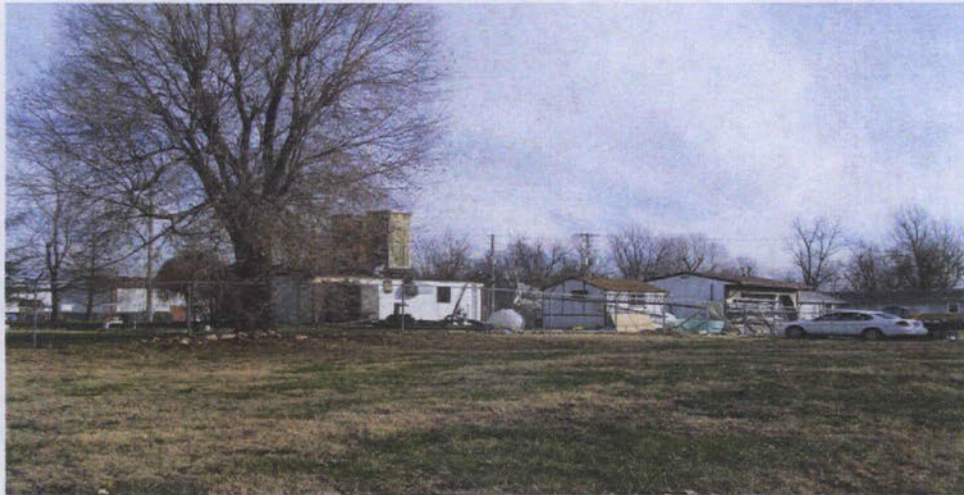
**Photograph 15**

Solid State Circuits Site, Republic, MO  
Date 12/08/2011, Wendell Hall, DEQ, SWRO  
Photo of SSC site, south of site and along Main Street.

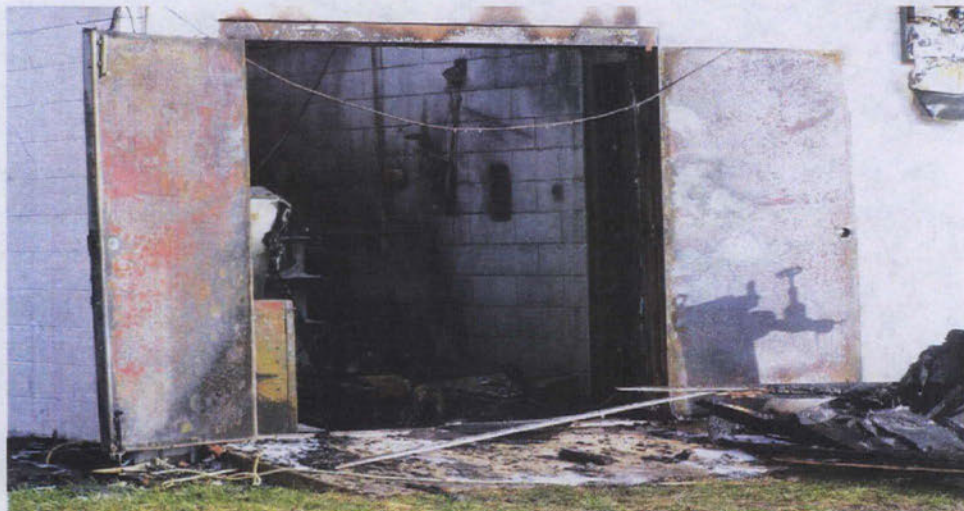
**Photograph 16**

Solid State Circuits Site, Republic, MO  
Date 12/08/2011, Wendell Hall, DEQ, SWRO  
Close-Up photo of entrance to Equalization Tank Room

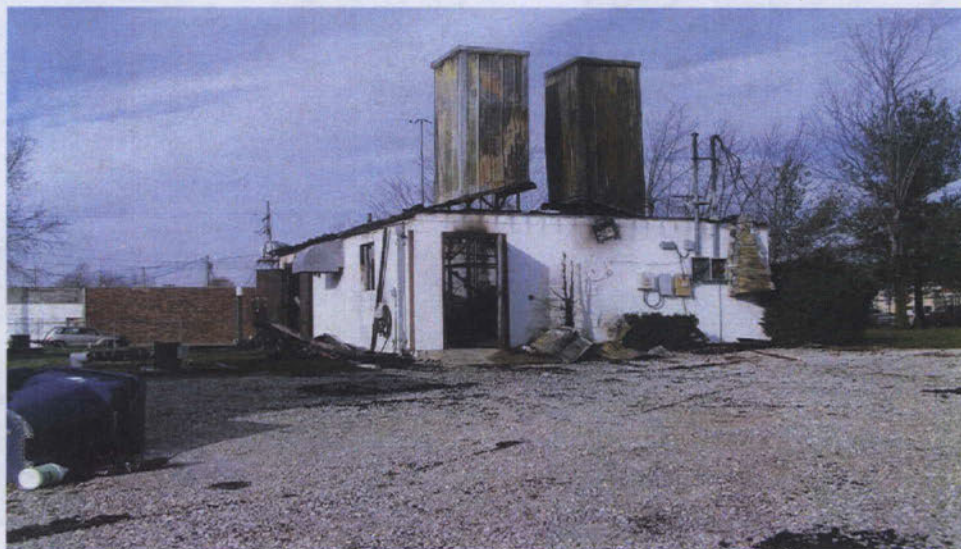
**Photograph 17**

Solid State Circuits Site, Republic, MO  
Date 12/08/2011, Wendell Hall, DEQ, SWRO  
Photo of entrance to Air Stripper Room along east side of building.
